BUILDING SCIENCE SERIES 40

Engineering Aspects of the 1971 San Fernando Earthquake

This report presents the observations of the NBS on-site inspection team (most photographs in this report were taken by the team). The material presented herein is intended to serve as (1) a documentation of damage resulting from the earthquake and (2) as a source document for further studies, research, and recommendations. This is particularly important as necessary remedial work and restoration have resulted in the removal of evidence that is essential for studies and evaluations.

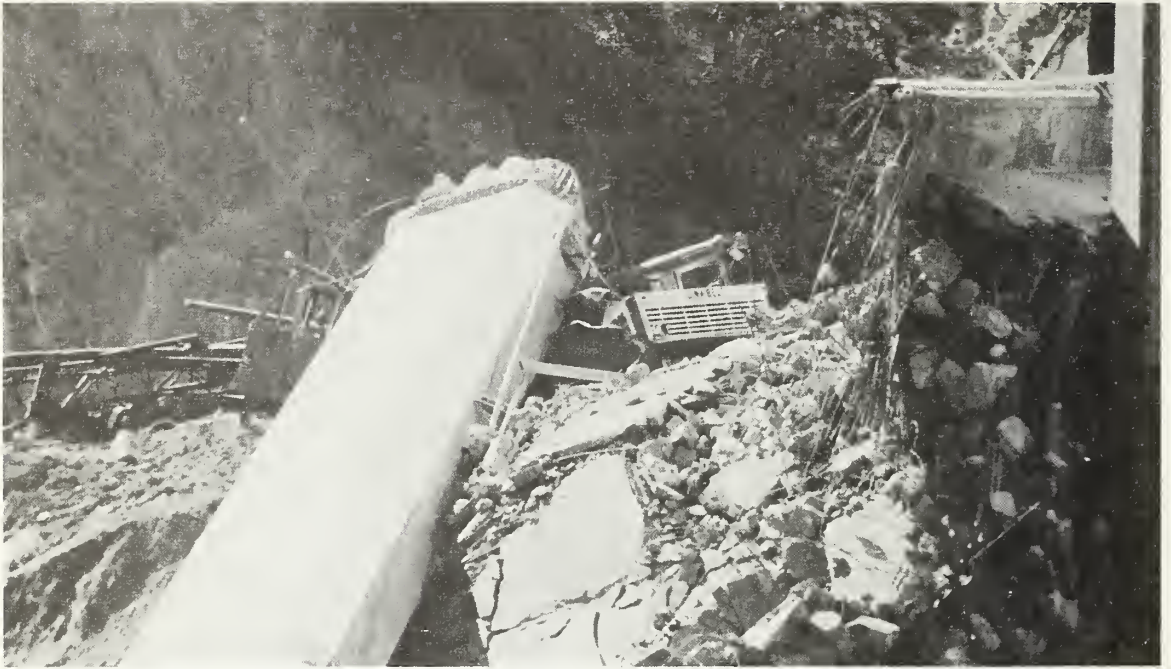
Figure 7.8 The top of Pier 5 and girder debris from the South Connector Overcrossing.

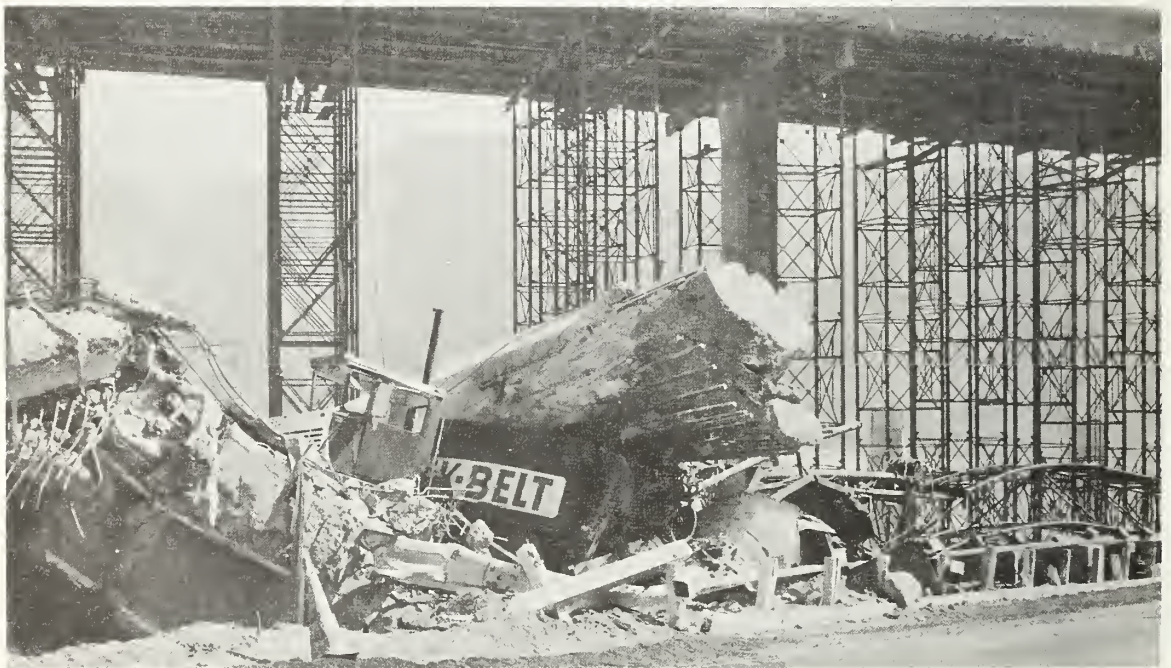
Figure 7.9 The top of Pier 5, which was embedded in the girder diaphragm, resting on the construction crane after collapse.

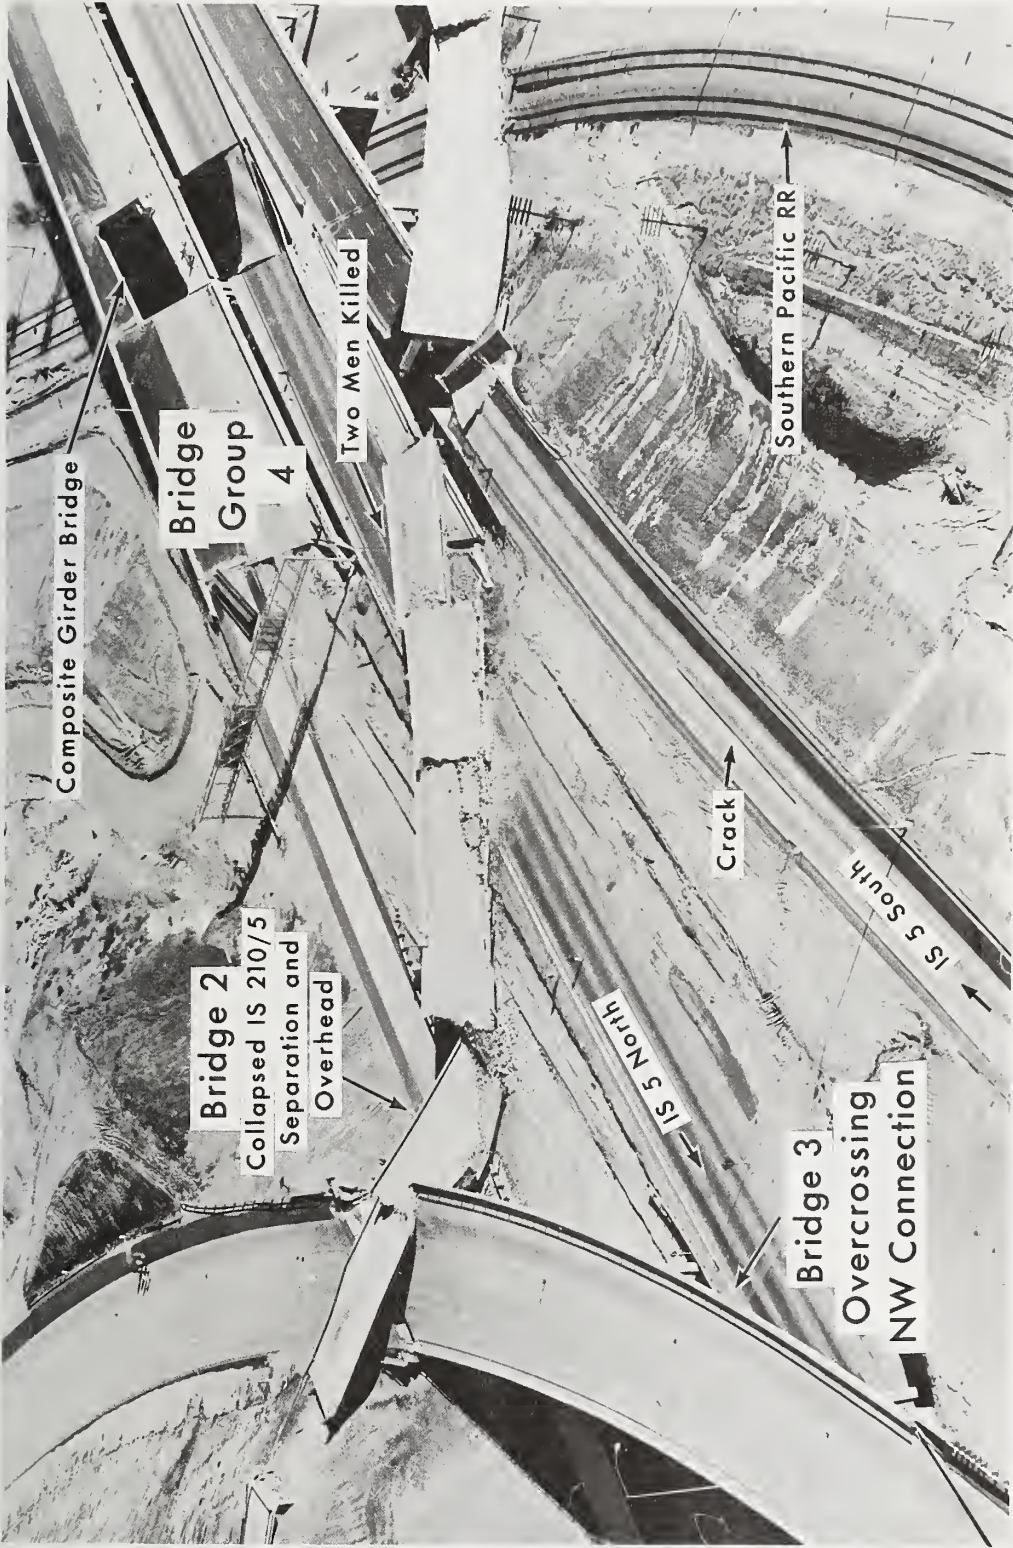
This complex interchange, much of which was completed and open to traffic, suffered extensive damage and must be almost completely rebuilt. Figure 7.10 is an aerial view of the freeway interchange looking north toward San Fernando Pass and Newhall. The collapsed IS 210/5 Separation and Overhead caused major damage to the Golden State Freeway (IS 5), the Foothill Freeway (IS 210), the San Fernando Road (which paralleled the railroad), and the Southern Pacific Railroad tracks. The collapse of the Separation and Overhead resulted in the loss of the lives of two men who were passing underneath it in a pickup truck. Additional detail can be seen in figure 7.11. In addition to the collapsed Separation and Overhead structure (Bridge 2), the Northwest Connector Overcrossing (Bridge 3) was severely damaged from the impact of Bridge 2 and must be removed and replaced. The series of essentially parallel spans carrying IS 5 South and IS 5 North, and the northbound truck routes over the Southern Pacific Railroad tracks and San Fernando Road (Bridge Group 4) were also destroyed. Some spans of this bridge group were impacted by the falling IS 210/5 Separation and Overhead, while one steel girder span collapsed by dropping off its bearings. This complex represented various types of bridges, including reinforced concrete box girders, precast prestressed I-beam girders, and concrete-steel composite girder bridges. Immediately to the east of this group, Bridge 5 (as shown in fig. 7.12) was a two span cast-in-place prestressed box girder with a longest span of 122 ft. It was supported by a single column bent founded on 16-in diameter cast-in-place drilled shaft piles. The structure suffered major column damage and was removed. Because of the need to rapidly remove the destroyed and damaged bridges in order to reopen the

Figure 7.11 View looking east of the collapsed Separation and Overhead (Los Angeles Times Photo).

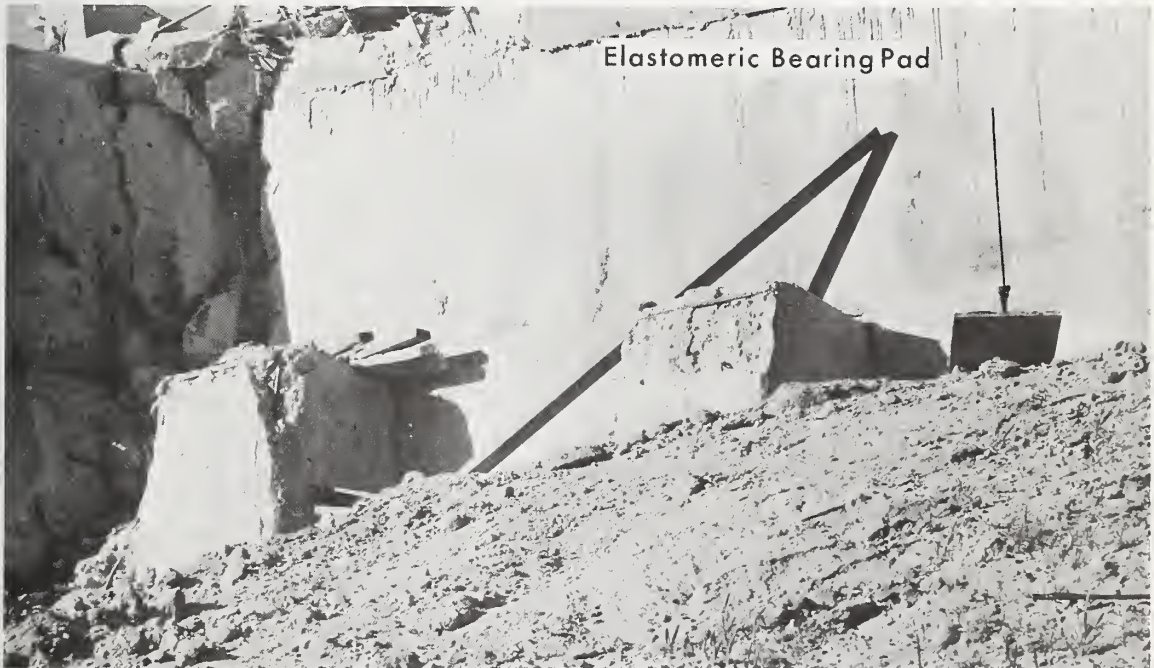
The collapsed IS 210/5 Separation and Overhead structure (Bridge 2) was a 7-span, nonprestressed, reinforced concrete box girder structure, carried on single column bents as shown in figure 7.14. This bridge was also curved in plan and had hinge details generally similar to those described previously for the bridge at the Palmdale interchange. The bridge was supported on elastomeric bearing pads on the pile-supported end abutments shown in the upper left of figure 7.15. A closeup of the abutment bearings at the north end is shown in figure 7.16. One of the elastomeric bearing pads can be seen lying next to the concrete bearing block. Another of these pads was found in a relatively undamaged state adhering to the under side of a box girder web after the girder had fallen approximately halfway down the slope. The appearance of the concrete pedestals in figure 7.16 indicates that the girders slid off the pedestals fairly rapidly.

Figure 7.16 Close up of east abutment and elastomeric bearing pad.

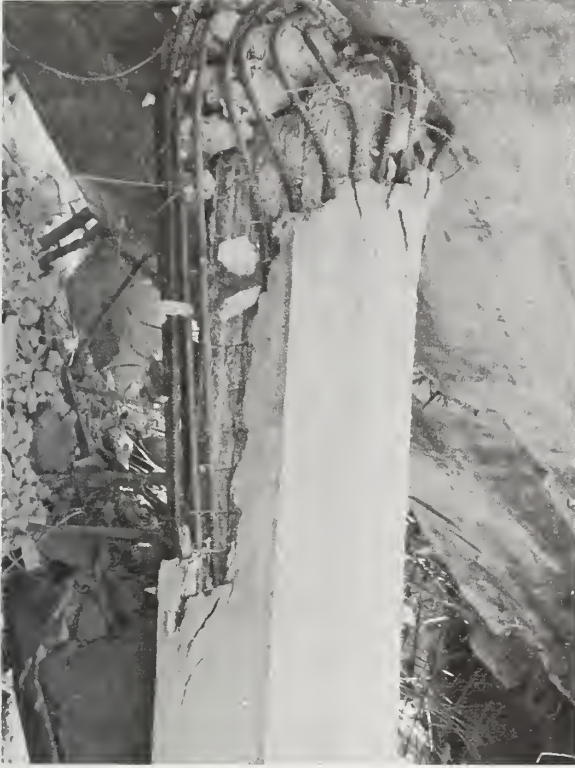
Figure 7.19 Column-girder connection with major distress in the column. Note the separated column hoops.

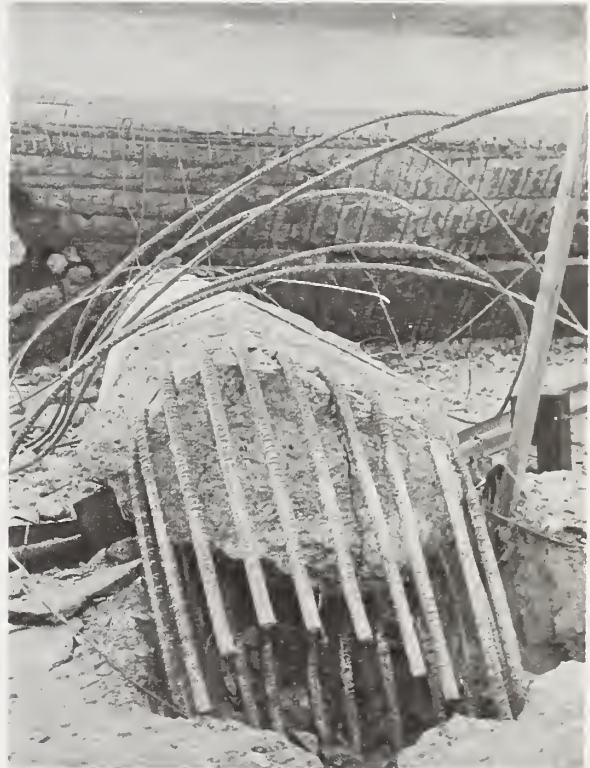
Figure 7.20 Base of the column which pulled out from the 6-ft diameter cast-in-place drilled shaft. Note the stripping of the reinforcement of the bottom of the girder in the background of the picture.

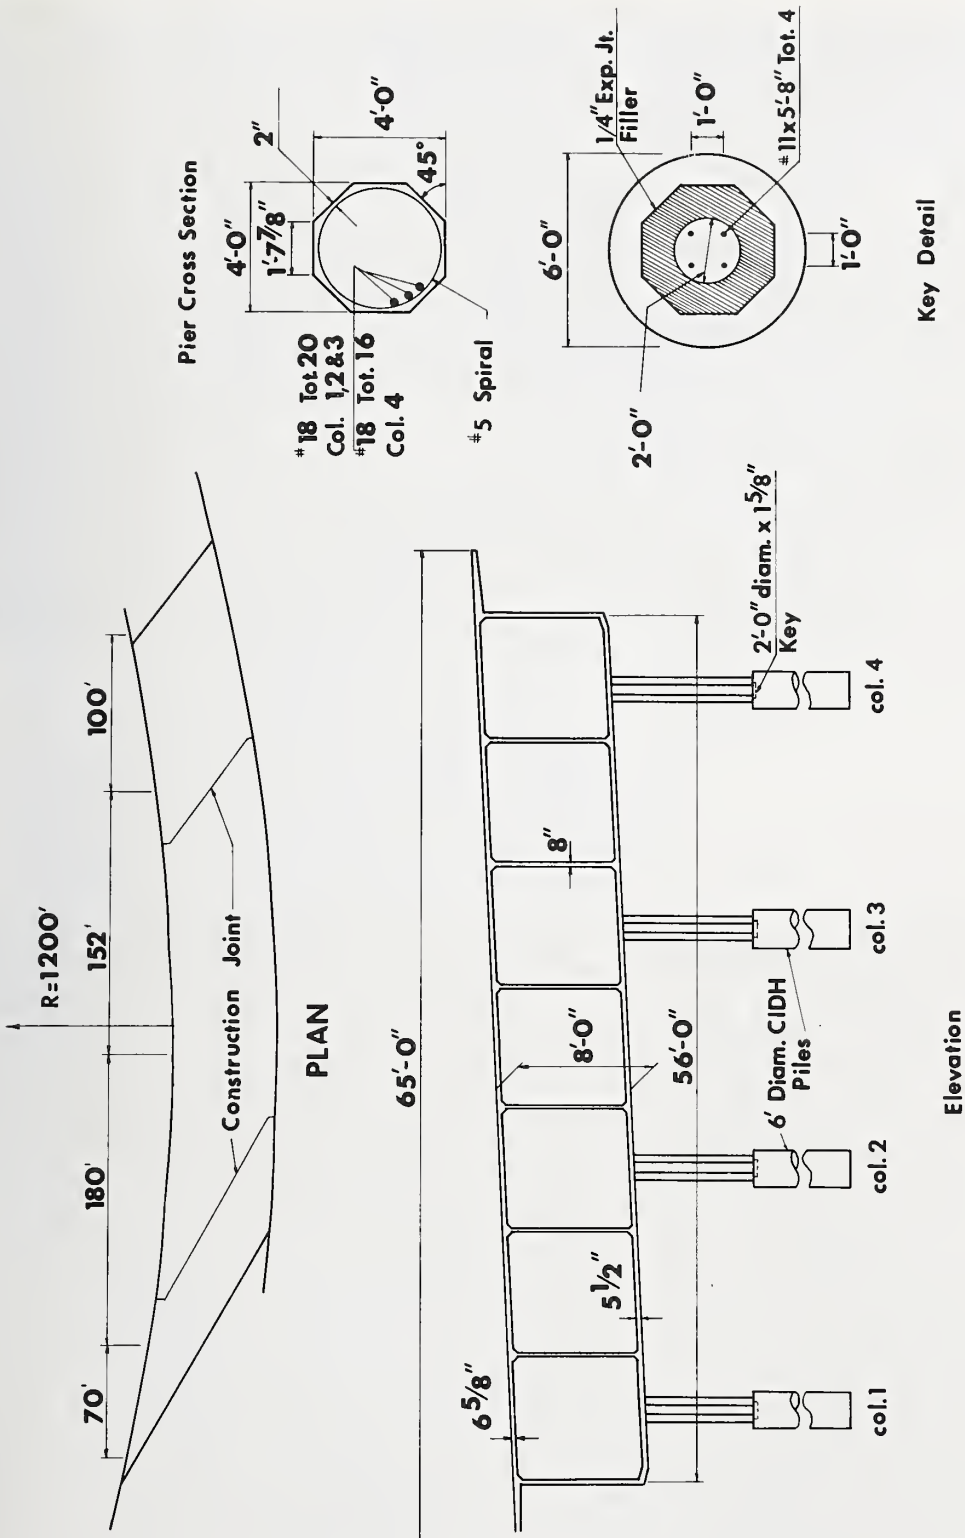
The Northern Connector Overcrossing (Bridge 3 in figs. 7.1 and 7.10) was a skewed, curved, 7-cell cast-in-place reinforced concrete box girder bridge. It had four spans of 70 ft, 180 ft, 162 ft, and 100 ft, and was carried on three- and four-columns bents, as shown in figure 7.21. The columns were octagonal, inscribed in a 4 ft square as shown and were reinforced with 16 to 20 No. 18 bars, which were surrounded by a No. 5 spiral at a 5-in pitch. Reinforcement was Grade 40 and column concrete was 4000 psi compressive strength. The columns rested on 6-ft diameter cast-in-place drilled shaft piles which were reinforced with 22 No. 11 bars, which extended approximately 15 ft into the pile. The columns in all bents were essentially hinged at the base where they connected to the cast-in-place pile using a 2-ft diameter by 1 5/8-in thick keyway, with only four No. 11 bars crossing it, as shown in the key detail in figure 7.21.

Figure 7.21 Important details of the Northwest Connector Overcrossing.

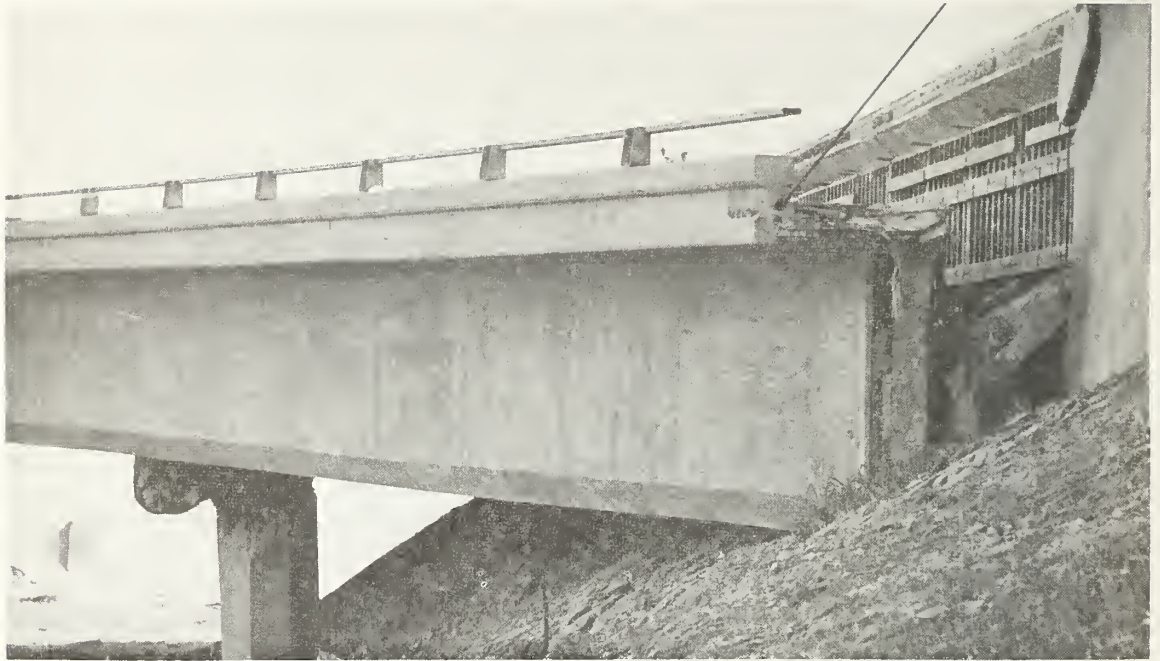
This structure was struck by the falling South Connector Overcrossing at its south and east end, as shown in figure 7.18. This impact added to the natural acceleration forced the structure northward, and because of the skew angle it slid in a northeast direction at the northern end, as shown in figure 7.22. The line of columns at bent 2 on the north edge collapsed with increasing distress from west to east, as shown in figure 7.23. Note that the columns are virtually uncracked near their base and over the lower two-thirds of their height. The action of the No. 5 spirals in holding the columns together is apparent and can be seen in detail in figure 7.24. In this same photo the relatively undamaged appearance of the girder at the column-girder connection can also be seen. Because of the damage to the substructure and in order to expedite the restoration of traffic, the entire structure is slated for removal and replacement.

Figure 7.22 Abutment and pier damage at the western end of the Northwest Connector Overcrossing.

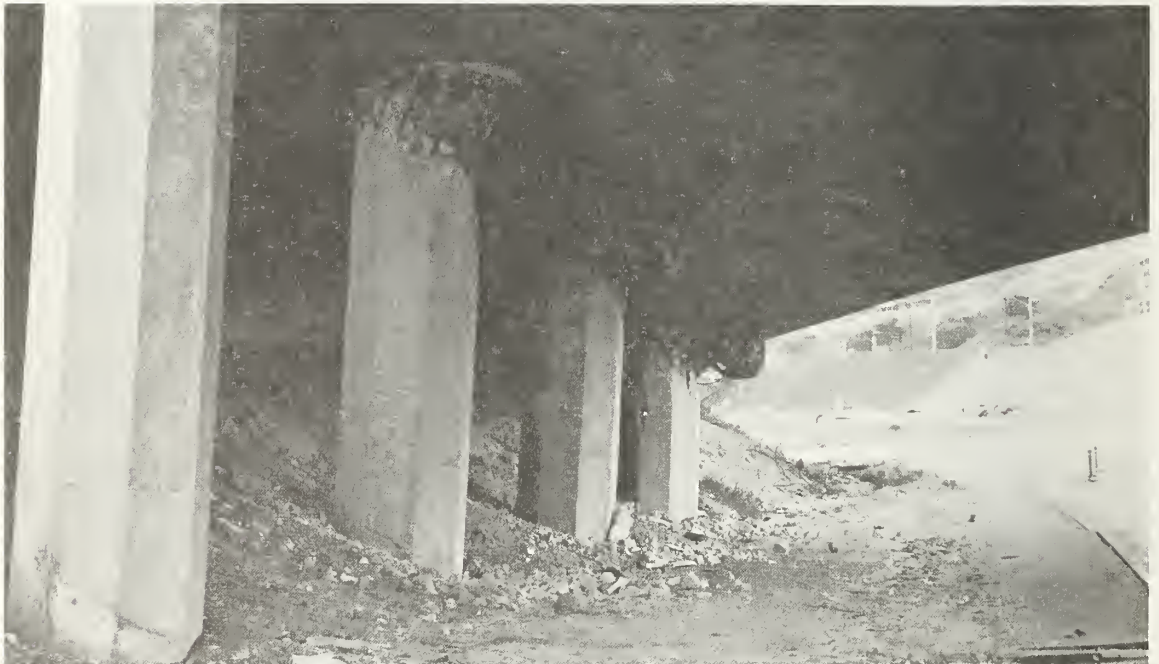
Figure 7.23 Spiral column failures in bent 2 at the west end of the Northwest Connector Overcrossing.

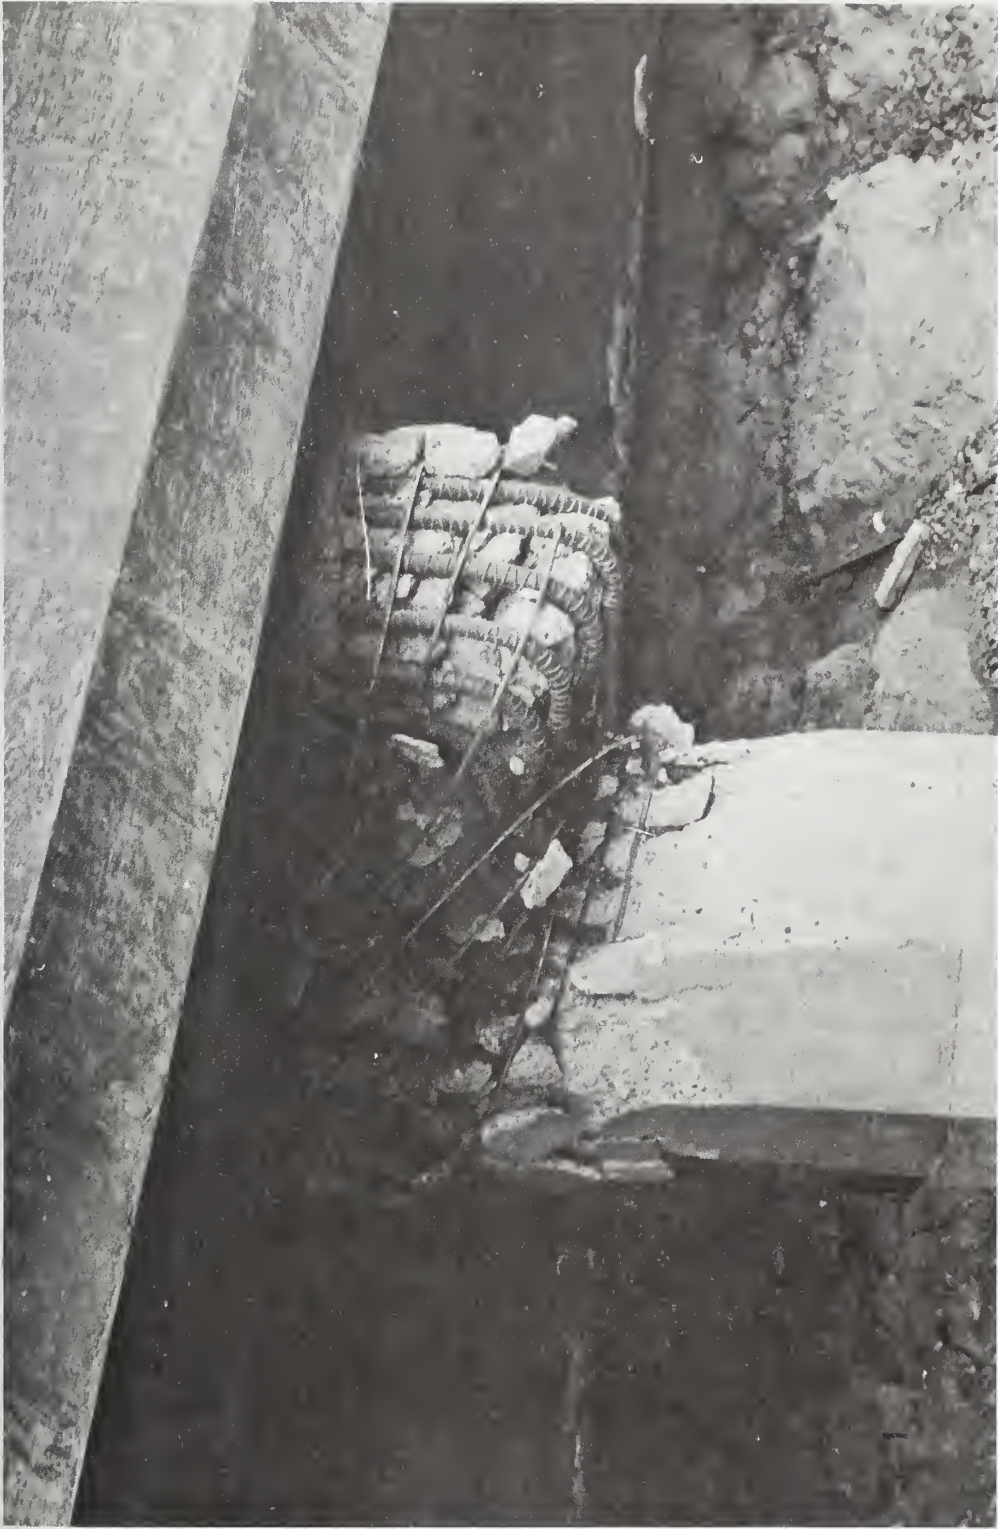
Figure 7.24 Close up of exterior spiral column.

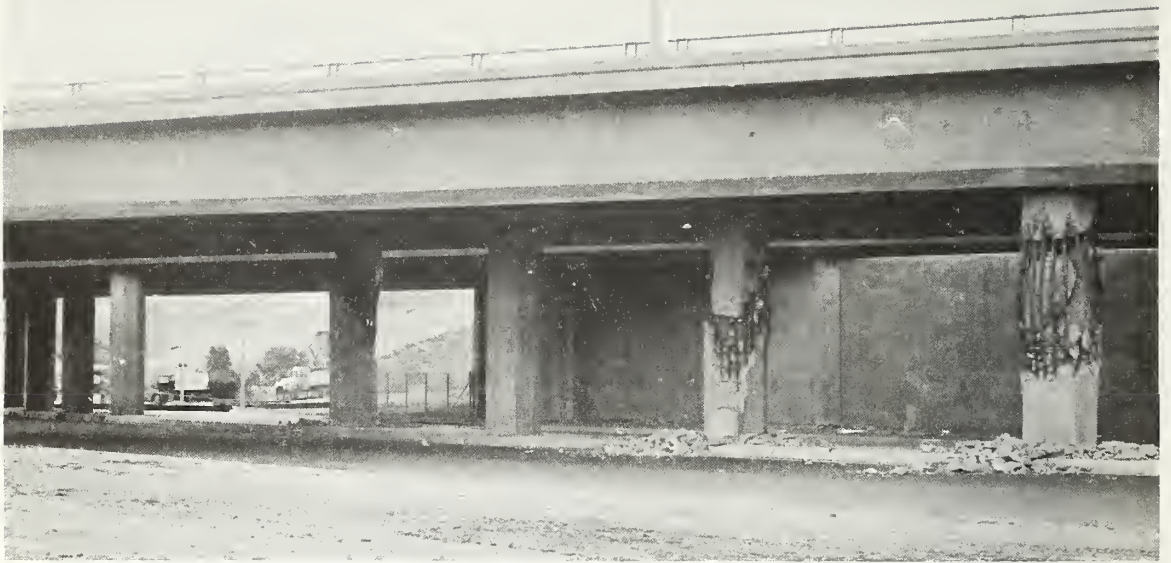
The major damages noted in this bridge was sustained by the southern or right bridge and were mostly in the columns and abutments, as can be seen in figure 7.26, which shows bent 3 of the right bridge in the foreground. The bridge had apparently twisted in a clockwise direction and it appeared that it had rotated about the third column from the right hand side of the photo, which is relatively undamaged. Severe damage was encountered in the other columns, as can be seen from the closeup in figure 7.27, which indicates complete destruction of the core concrete and buckling of the bars, as well as loss of the relatively light hoops provided. Note the hoops lying in the rubble in the foreground. The columns of bents 2 and 4 were set in a series of closure walls and movement could take place only at the top, so the damage to these columns was fairly well confined to the very top portion, as shown in figure 7.28. In spite of the massive damage to the support elements, the girders appeared to be in surprisingly sound shape, and visual examination did not indicate any appreciable evidences of concrete cracks large enough to indicate reinforcement yielding.

Figure 7.26 Column failures in bent 3 of Foothill Boulevard Undercrossing.

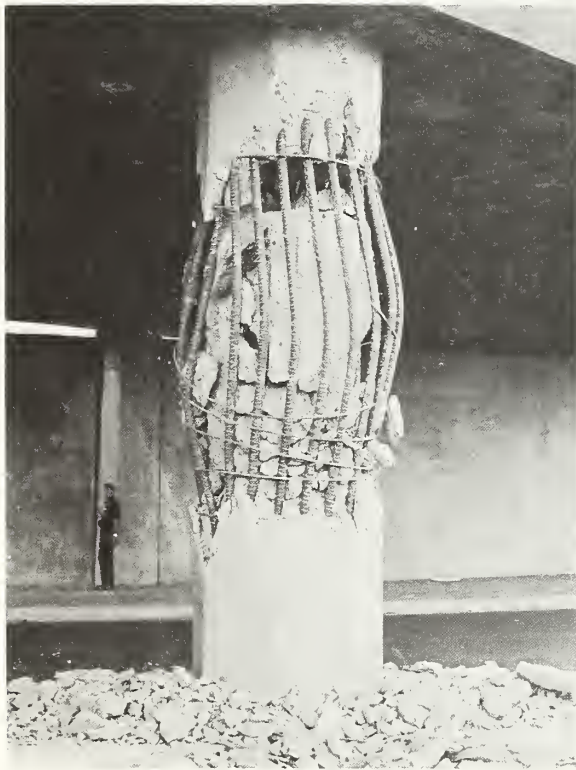
Figure 7.27 Close-up view of failure of a tied column in bent 3. Note hoops on ground in debris.

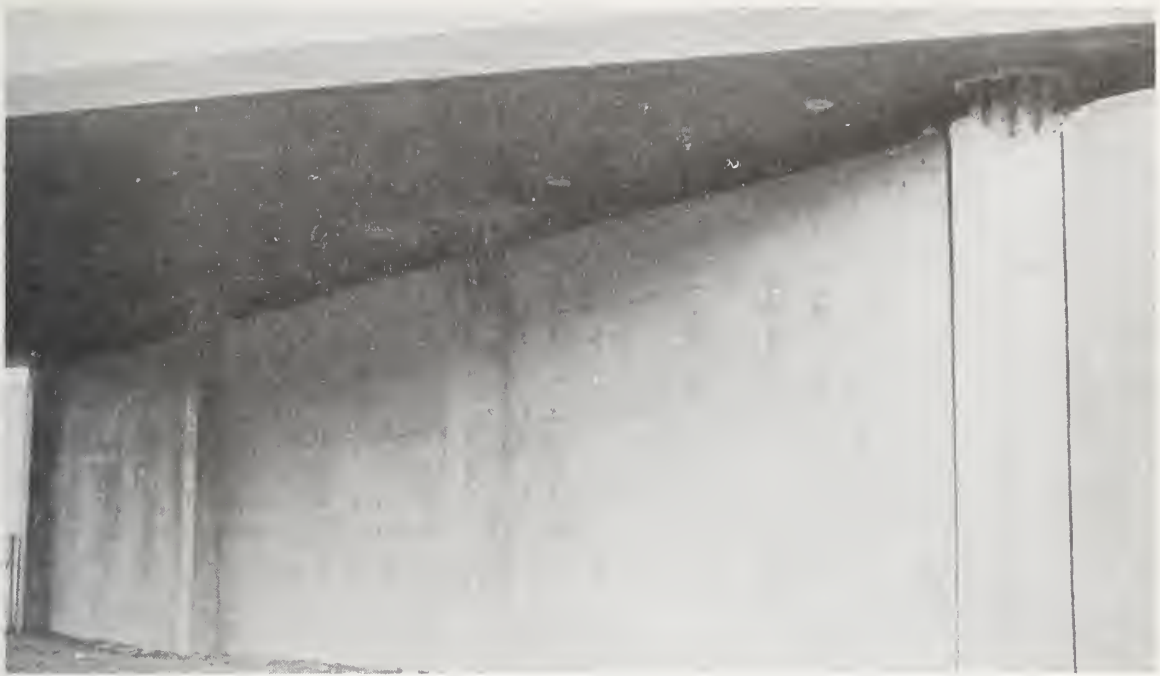
Figure 7.28 Damaged columns in bent 4 with 10-in closure wall which was separated from the columns by 1/2-in filled expansion joints.

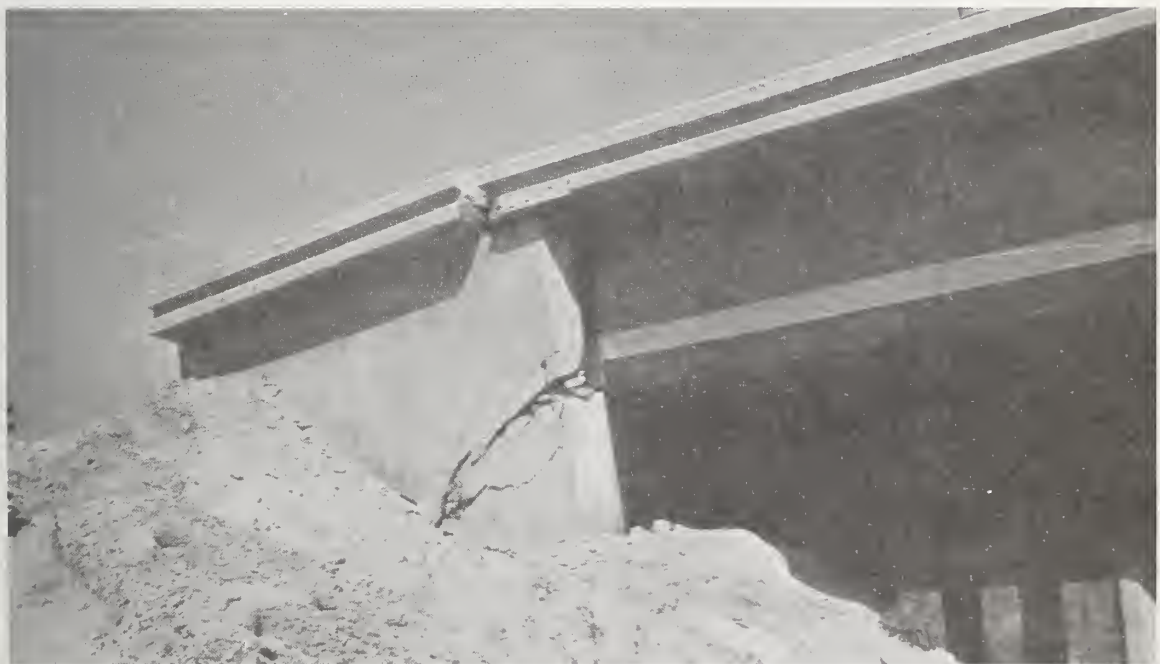
Throughout the remainder of the north San Fernando Valley, numerous bridges were damaged in a much less dramatic manner. A typical sight was extensive cracking in the abutments, similar to that shown in figure 7.29. In this case a major crack ran through the earth fill up to the bridge abutment, through the abutment and out the other side of the abutment. The bridge in this case was displaced

Figure 7.29 Typical abutment damage.

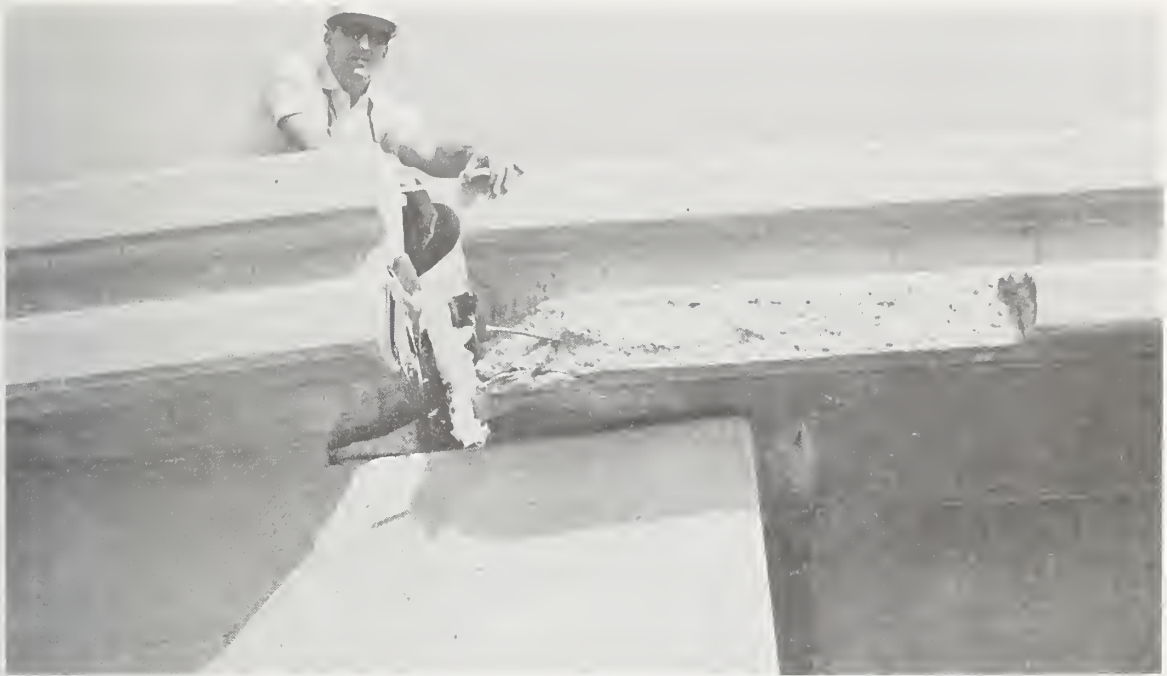
both longitudinally and transversely over 6 in, as can be seen in figure 7.30. This particular structure was a continuous reinforced concrete box girder bridge, located between the Palmdale and Foothill interchanges.

Figure 7.30 Longitudinal and transverse movement of cast-in-place box girders with respect to abutment sections.

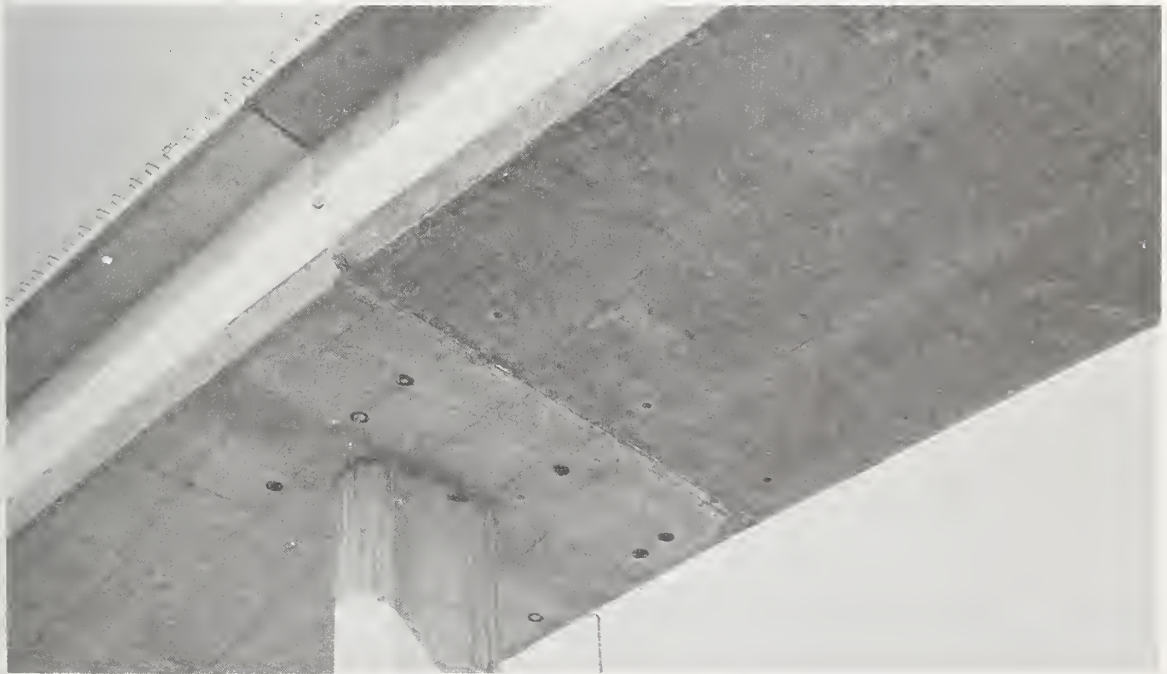
Bridges supported on tall, slender columns and piers seemed particularly susceptible to movement and bridges located several miles north of the Palmdale interchange indicated substantial movement at hinges, as shown in figure 7.31, and extensive butting of one section against another causing spalling as shown in figure 7.32. However, these damages can be classified as minor. Many of the bridges with heavy abutments came through with relatively light damage to concrete slope paving and no visible damage to the structure, as did the single span prestressed box girder bridge shown in figure 7.33. This bridge was located on the Foothill Freeway at Glenoaks Boulevard and is only a few blocks from Olive View Hospital.

Figure 7.31 Typical movement at a hinge joint of a slender box girder bridge.

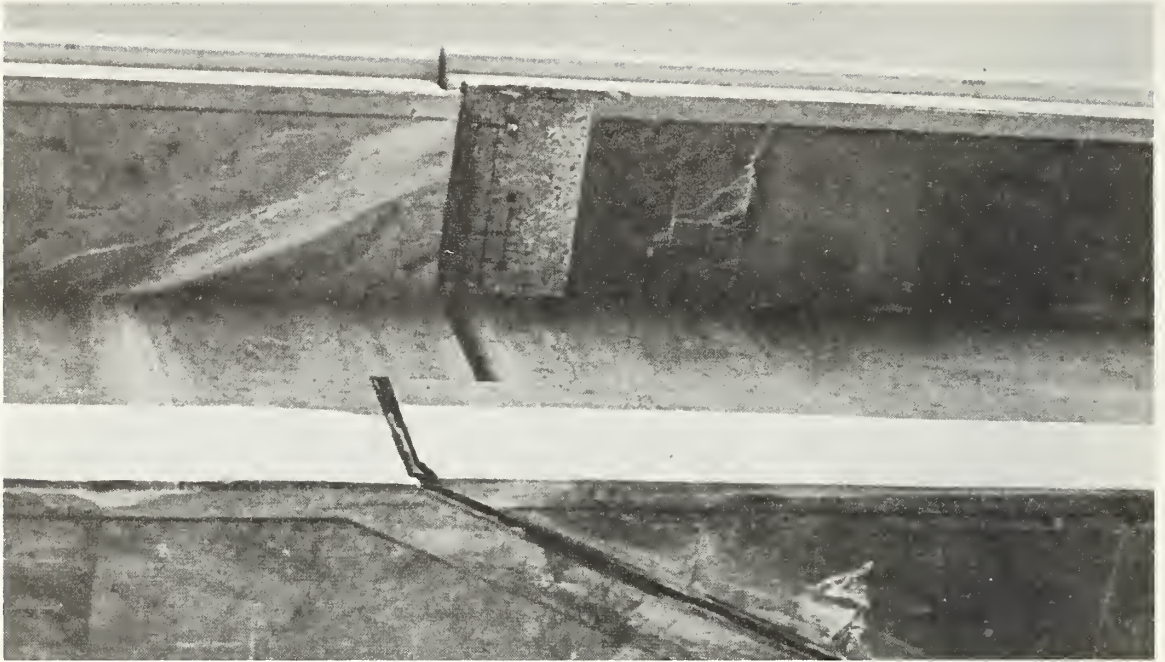
Figure 7.32 Typical movement and spalling at a joint in an elevated box girder bridge, caused by battering at the joints.

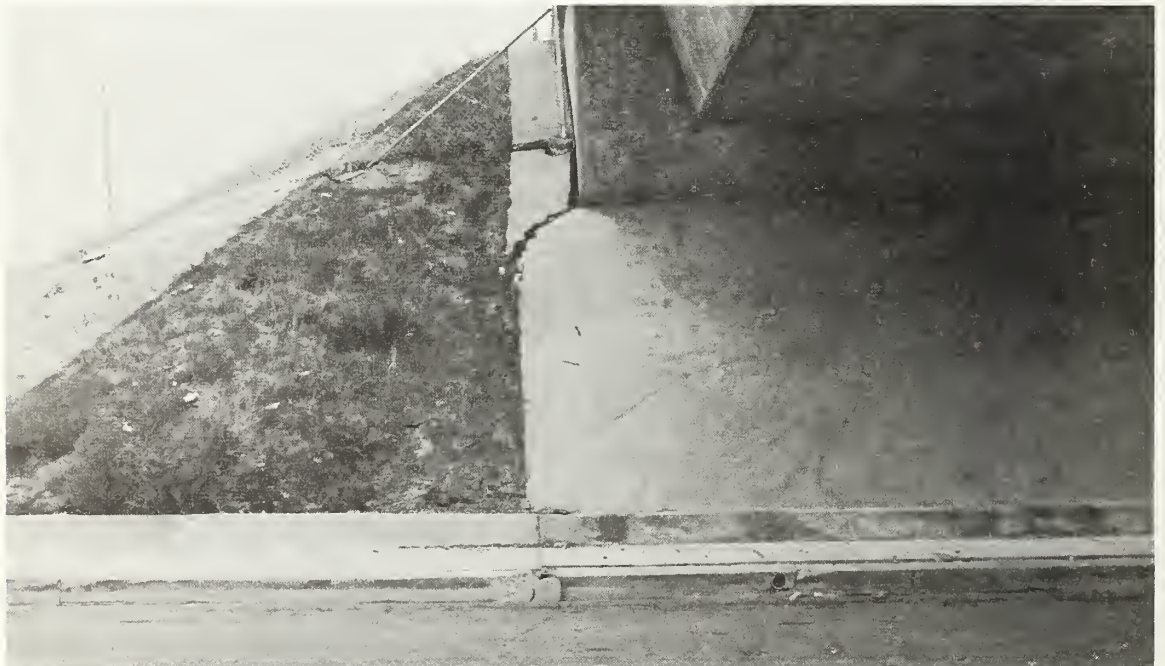
Figure 7.33 Typical damage to wing walls and sloped paving on a single span prestressed concrete box girder bridge.

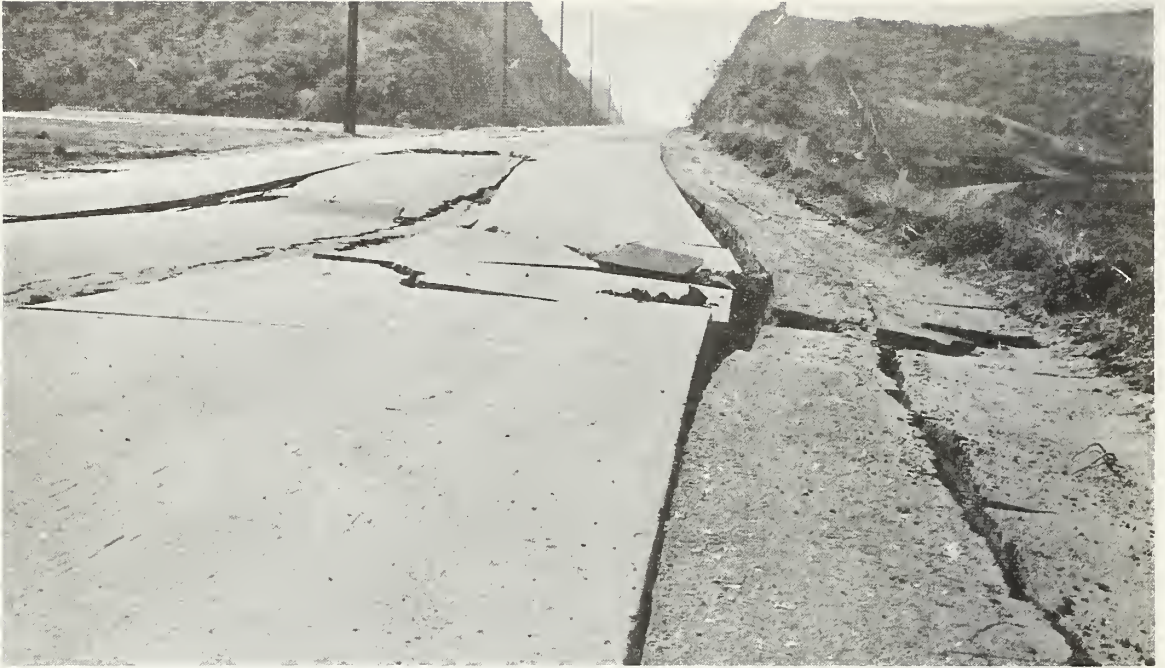
Blucher Avenue (figs. 7.35 through 7.37) was extensively damaged due to lateral and vertical movements of several feet. The extent of ground movement in the area is further illustrated by the ground cave-in shown in figure 7.38.

Figure 7.35 Road cave-in and ground cracks along Blucher Avenue along the eastern edge of the lower Van Norman Reservoir.

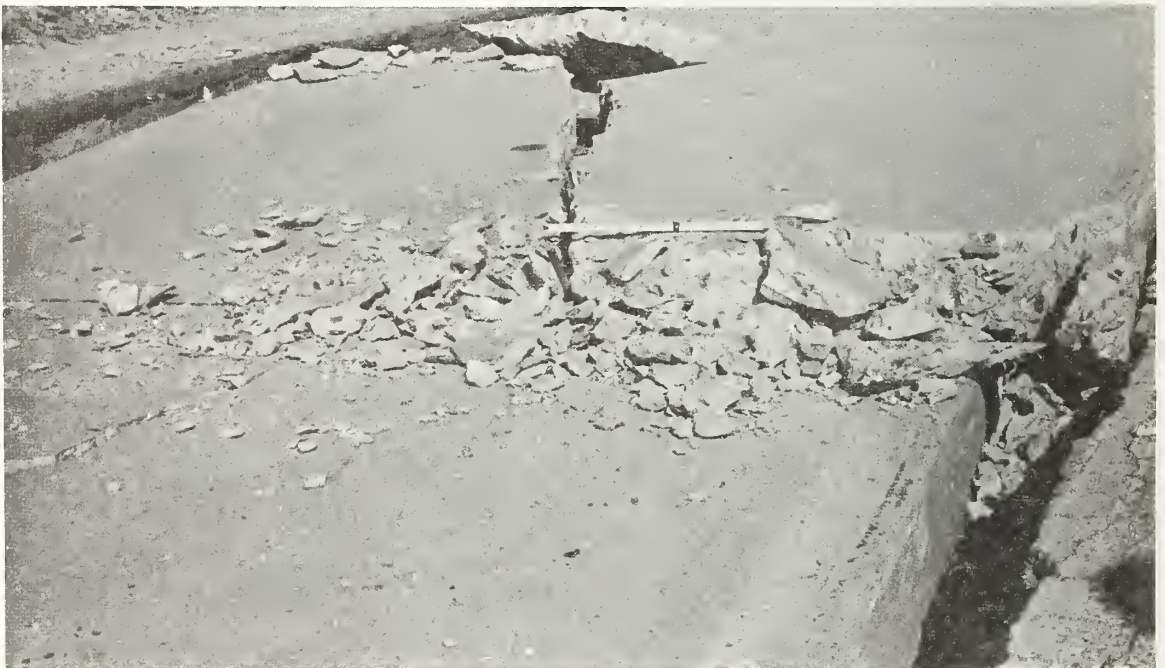
Figure 7.36 Concrete road slabs were crushed by the ground motion in this location.

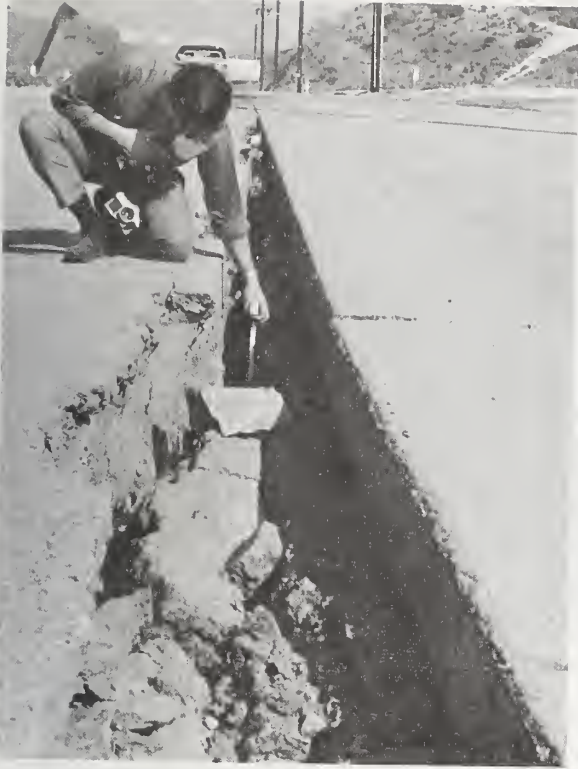
Figure 7.37 One of ground cracks along the road had a depth of at least 14 ft.

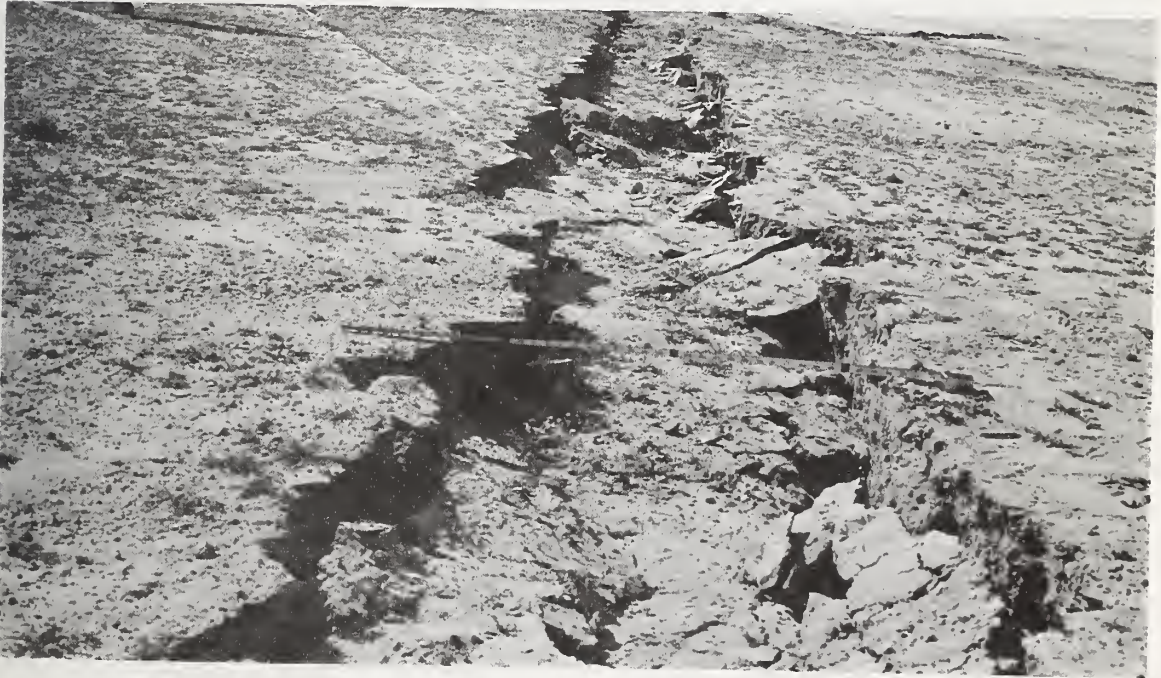
Figure 7.38 Ground cave-in (2-ft wide) near the damaged road slabs shown in figure 7.35.

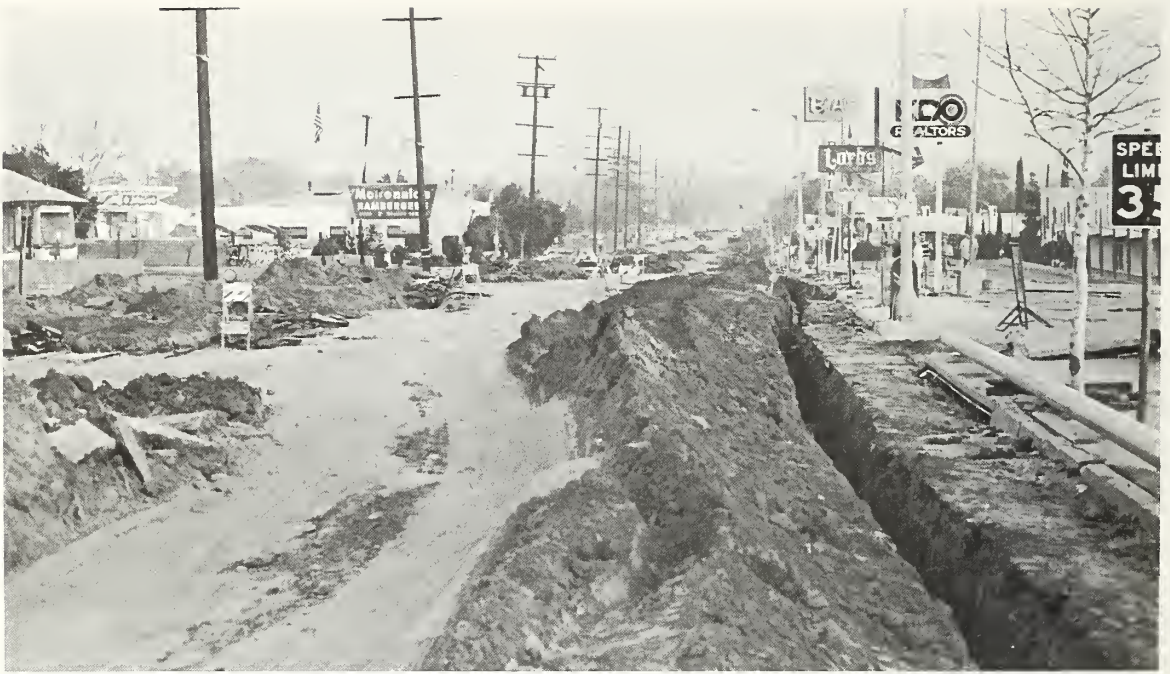
Some of the most spectacular damage occurred at the intersection of Hubbard and Glenoaks. As shown in figure 7.39, repair work was underway almost immediately. Considerable street damage was caused by gas line explosions. Further evidence of the ground movement is shown in figure 7.40.

Figure 7.39 Broken gas, water, and sewer lines being repaired near intersection of Hubbard Avenue and Glenoaks Boulevard, San Fernando.

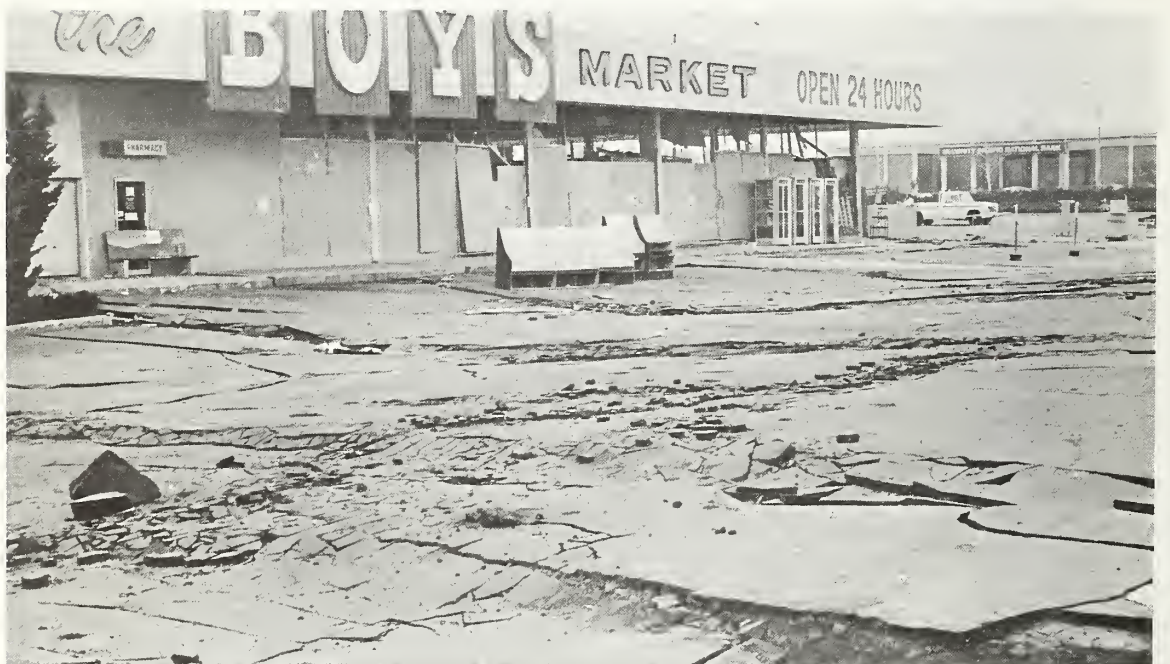
Figure 7.40 Considerable ground movement is evident in the parking lot of the shopping center at the corner of Hubbard Avenue and Glenoaks Boulevard.

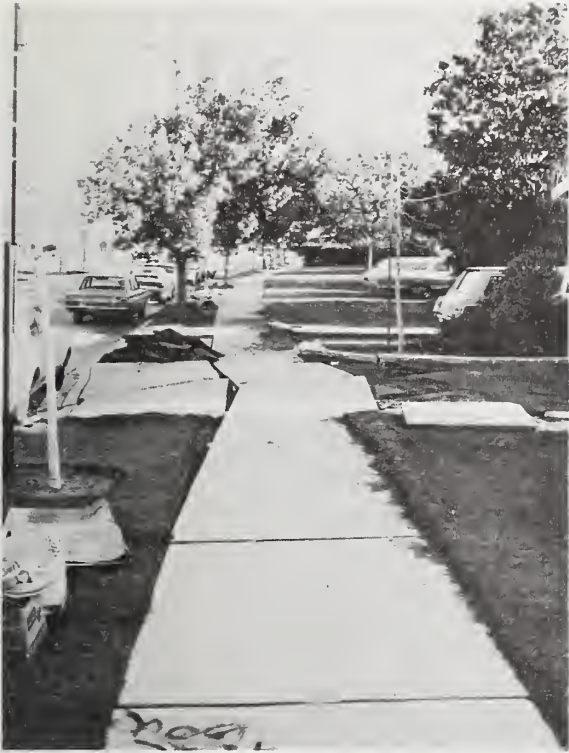
Damage to streets, driveways, and sidewalks is illustrated in figures 7.41 and 7.42. The ground movements in this area were on the order of four feet horizontally.

Figure 7.41 Sidewalk along Knox Street, near Orange Grove Avenue, San Fernando. Horizontal ground movement is clearly evident.
